District of Port Hardy
Wastewater Treatment Plants
& Collection System

Annual Operations Report 2011

**RECEIVING ENVIRONMENT WATER SAMPLING
FOR THE TSULQUATE WASTEWATER
TREATMENT PLANT IN HARDY BAY, BC**

**RECEIVING ENVIRONMENT WATER SAMPLING
FOR THE AIRPORT WASTEWATER
TREATMENT PLANT IN PORT HARDY, BC**

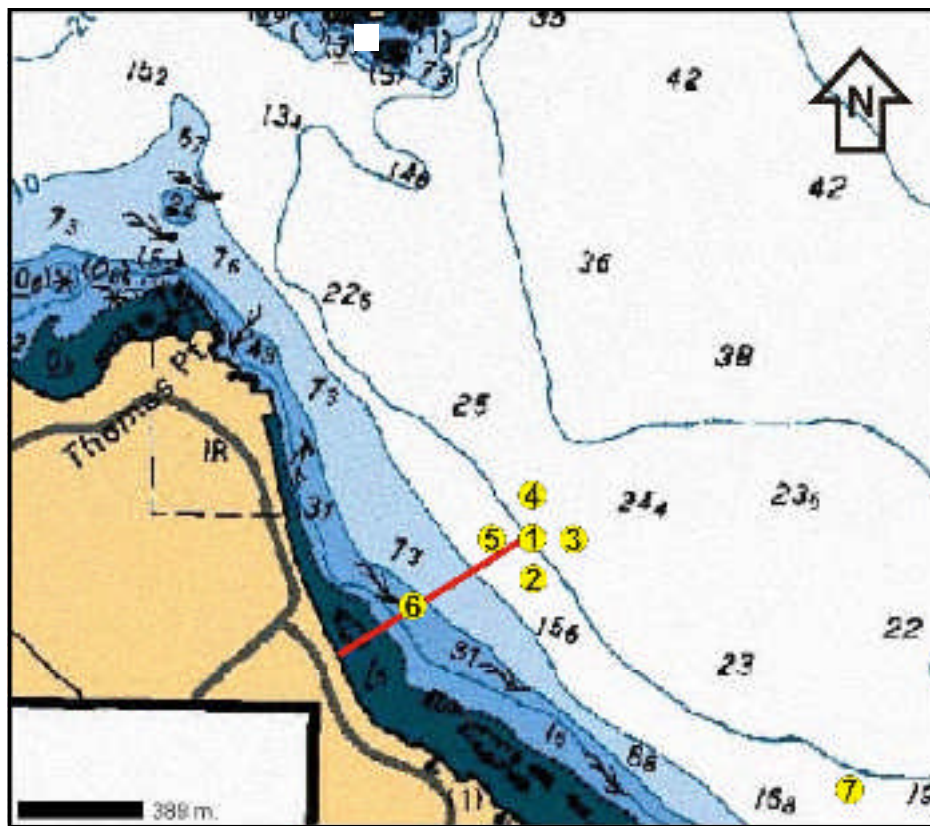
Figure 2. Airport outfall discharge receiving waters sampling locations, Port Hardy, BC.

A total of 7 sample stations were selected for receiving environment monitoring (Figure 2, Table 1).

1. **Outfall Terminus**
50° 41.608'N, 127° 22.178'W
2. **50m South of terminus**
50° 41.598'N, 127° 22.183'W
(Within the initial dilution zone from outfall terminus)
3. **50m East of terminus**
50° 41.659'N, 127° 22.039'W
(Within the initial dilution zone from outfall terminus)
4. **50m North of outfall**
50° 41.750'N, 127° 22.185'W
(Within the initial dilution zone from outfall terminus)
5. **50m West of outfall**
50° 41.701'N, 127° 22.330'W
(Within the initial dilution zone from outfall terminus)
6. **Reference**
50° 41.546'N, 127° 21.175'W
(Located outside the initial dilution zone as required by the municipal sewage regulation Part 27(c).
This reference station was located approximately 1000 m away from the outfall's initial dilution zone.)
7. **Near shoreline proximate to outfall**
50° 41.533'N, 127° 22.415'W
(located part way along the outfall line at 20' water depth)

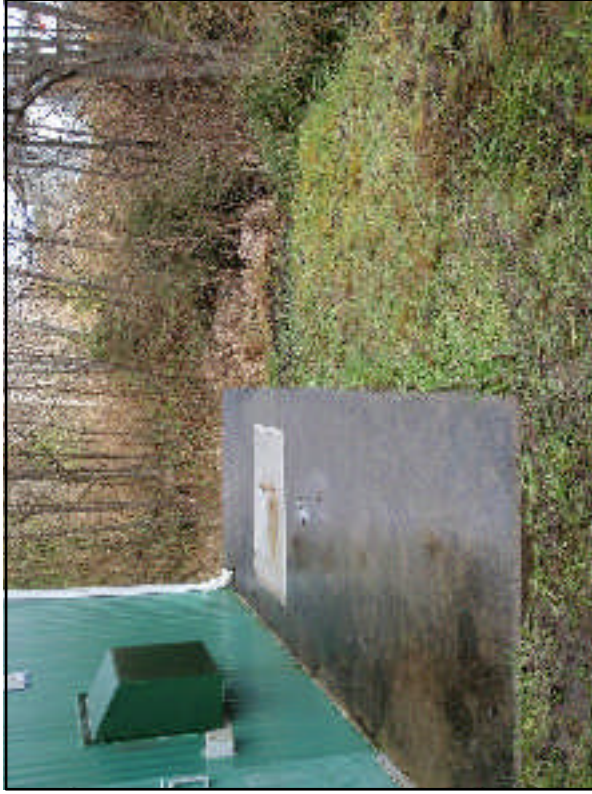
EPCOR was notified by a local resident that a spill was present at the Peel Street lift station in the morning of April 8th, 2011. EPCOR crew was immediately sent on site to assess the situation. An estimated spill volume of 100L of grey water was reported to PEP but the actual time and the date of the start of the spill were unknown. Myriam Belisle, BIT, of Pacificus arrived on-site around 10:00. EPCOR representatives had already identified and solved the electrical defect that was at the origin of the overflow. A back-up generator was immediately brought on site to remediate for the defective Smart-UPS through which all electrical system was connected. Upon arrival on site, most of the overflow grey water had been washed down by a water hose from the surface of the wet well and from the lawn (Photo 2). Small hygienic products and big pieces of toilet paper were hand-picked from the lawn.

Photo 1. Location of the spill at the Peel Street and Beaver Harbour lift station.

It is believed that EPCOR followed their respective Emergency Response procedures and took appropriate action to resolve and manage the wastewater spill. An additional Smart-UPS was installed to replace the defective one at the end of the day on April 8th, 2011 to prevent such event to happen again in the future.

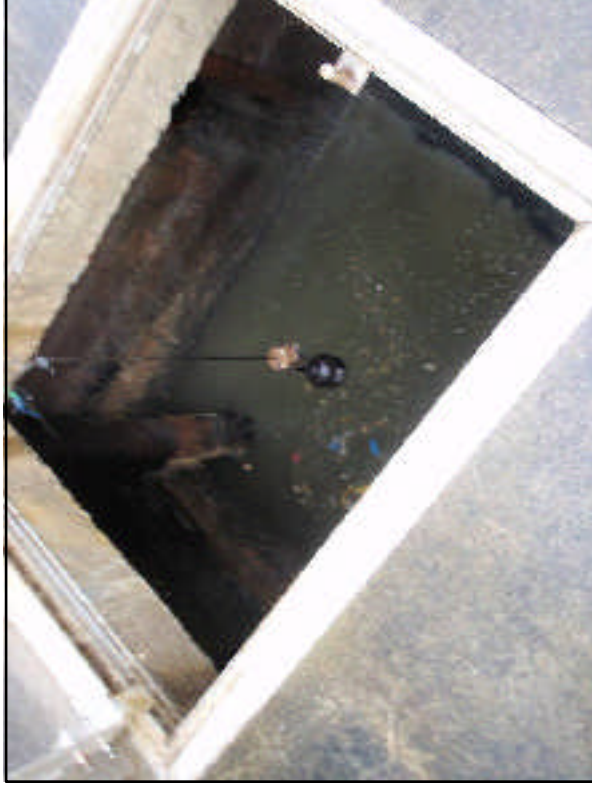
Photo 2. The overflow of the wet well (on this photo) was at the origin of the spill.

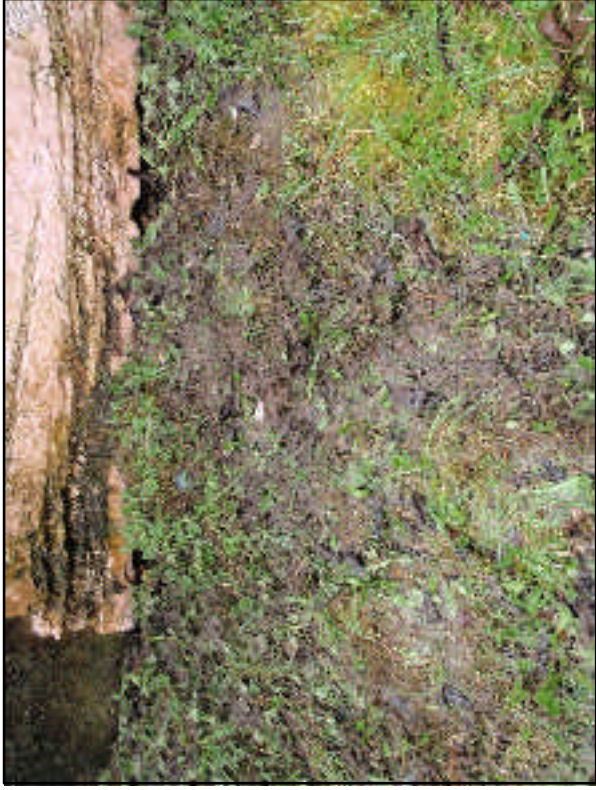
Only fine toilet paper particles remained on the lawn (Photo 3). EPCOR and Pacificus crews walked downstream of the spill within the adjacent stream and did not observe any residual waste that may have been introduced by the spill. Existing residential refuses (i.e. plastic bags, metal fences, etc) were observed within the affected area. The stream had an average width of 1.5m, a riffle-pool morphology and had a moderate flow at the time of the survey (Photo 4).

Photo 3. Residual grey water and toilet paper fiber remained on the lawn at the area of the spill.

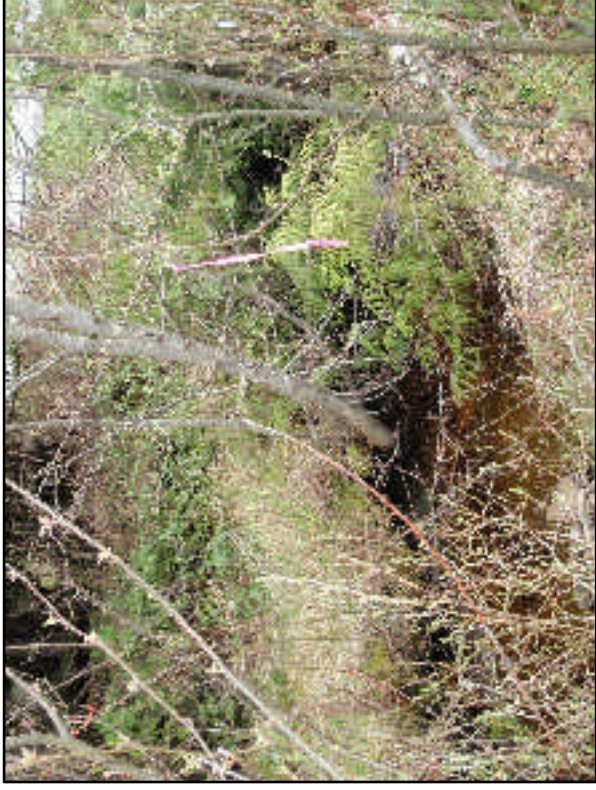
Photo 4. Upstream water sampling site in the unnamed stream adjacent to the spill location.

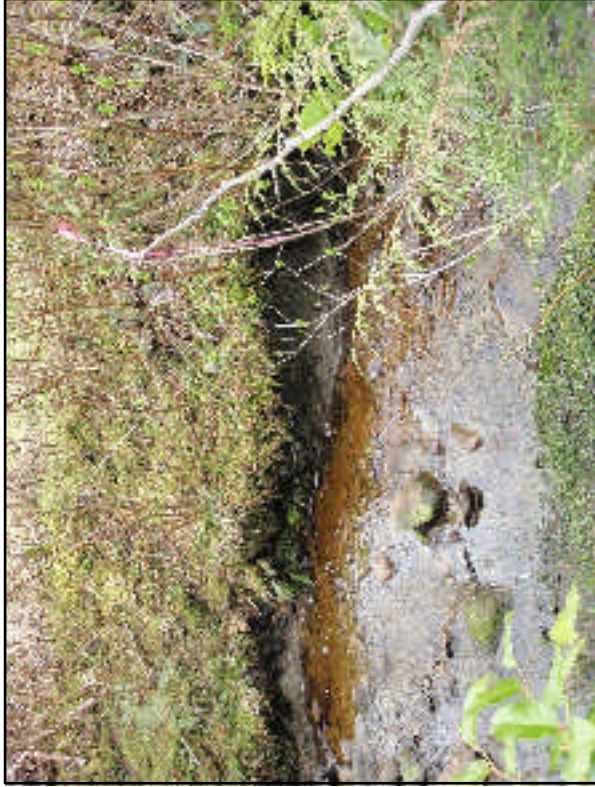
Photo 5. Downstream water sampling site within the unnamed stream adjacent to the spill location.

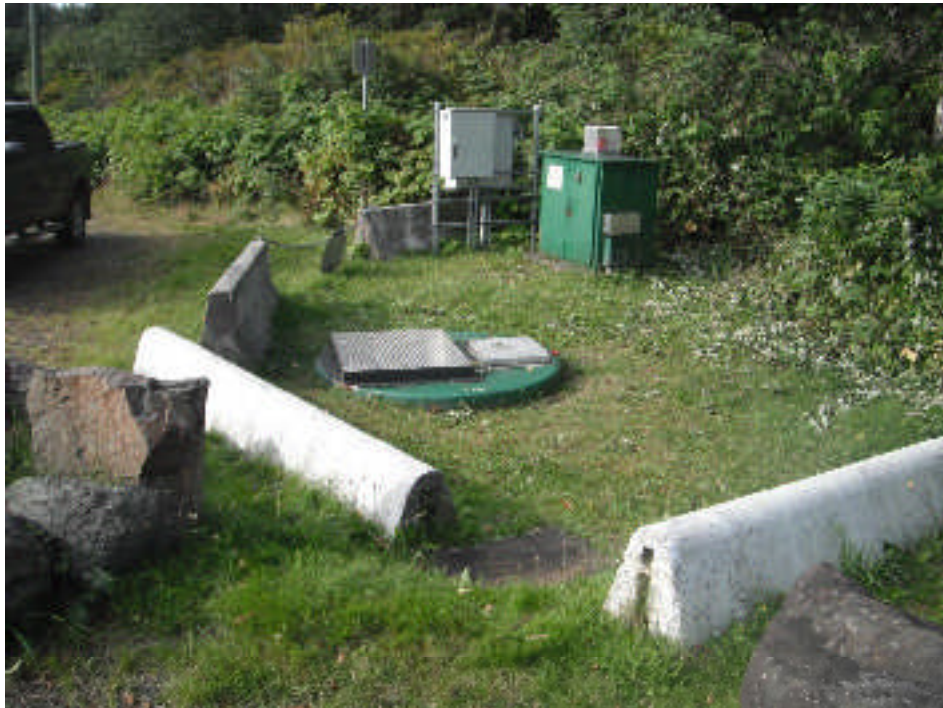
An onsite meeting was conducted in regards to the spill and EPCOR informed Pacificus that an estimated 50-100L of greywater had spilled out of the lift station via an overflow pipe when the pipe failed to engage. The station is inspected by EPCOR once per week, thus the spill could have occurred at anytime following the inspection on August 21. Prior to the site visit, EPCOR informed staff that MoE had already been contacted regarding the spill.

Photo 1. Pioneer lift station observed on August 25, 2011 following the events of the grey water spill into the nearby Quatse River.

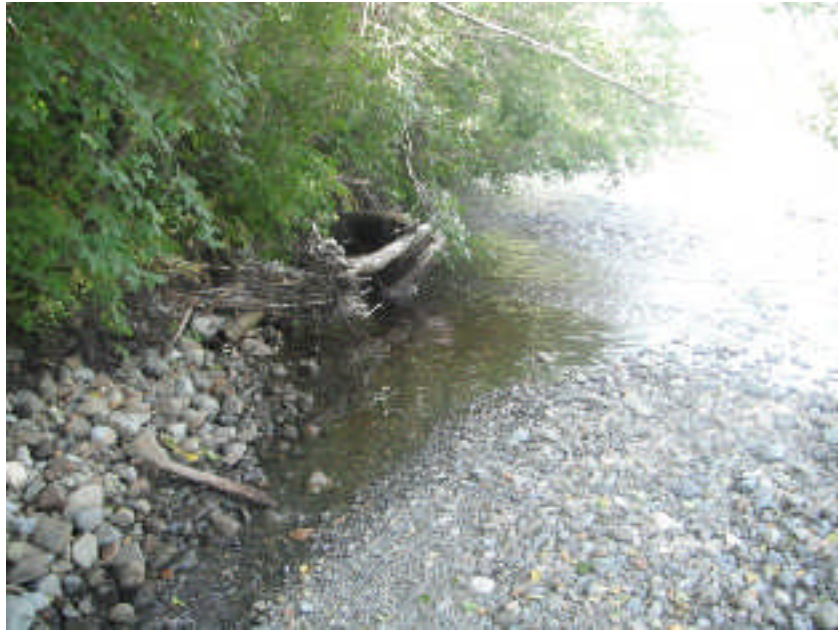
An assessment of the site found that the overflow pipe was dug into the bank downslope from the lift station and the outlet emptied into the Quatse River via a 3m section of vegetated bank and then an 8-10m long side channel composed of small gravel substrate off the mainstem (Photo 2). Greywater was observed to be pooling along the bank at the outlet of the overflow pipe. No other observable impacts to the Quatse River and the surrounding riparian vegetated were noted during the assessment. Inspection of the downstream confluence with the Quatse River showed no visible evidence of contamination, the water appeared clear with no visible evidence of particulate matter or bacterial growth.

Photo 2. The side channel, where the outfall pipe for the grey water overflow enters, confluencing the Quatsse River mainstem.

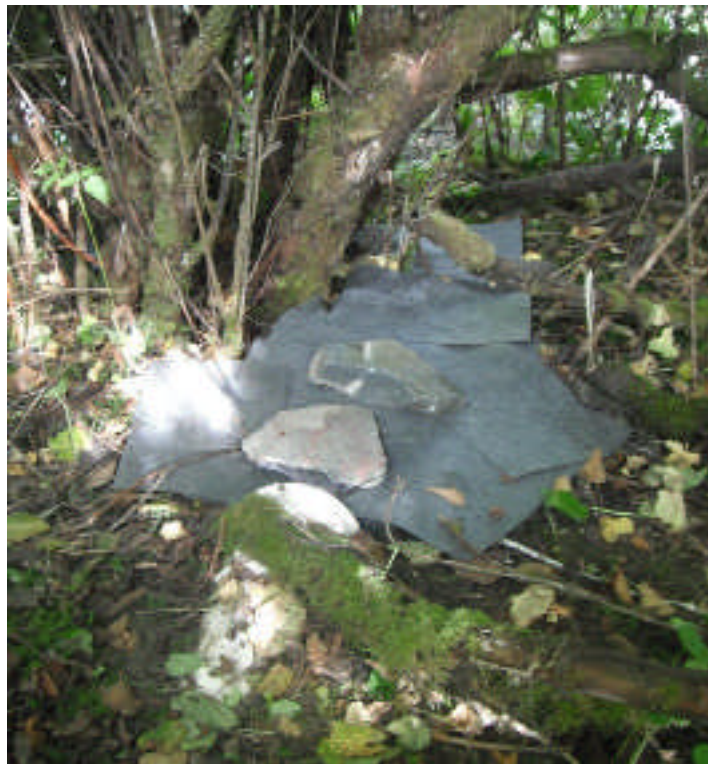
Photo 3. Absorbent spill pads used to clean up any observable grey water.

Following the site inspection, it was recommended that absorbent pads be used to clean up any remaining grey water found pooling along the bank and within the side channel (Photo 3). Water quality testing was also requested over a period of three days to ensure that there were no lasting impacts from the spill. The onsite biologist remained onsite to ensure that the existing spill material had been sufficiently cleaned up and there was no further grey water entering the system from the Pioneer lift station.
