DISTRICT  
OF  
PORT HARDY  
SEAGATE  
PIER  
BUILDING  
REFURBISH

ELEVATION

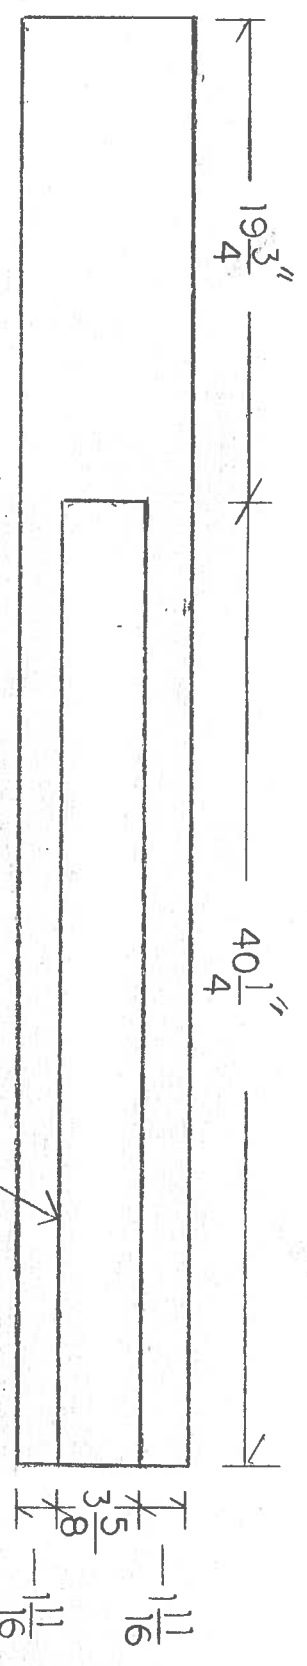
7 x 14 beam to be notched to receive the existing steel beam notch to be clean square and tight to existing beam joint between steel and wood to be scaled

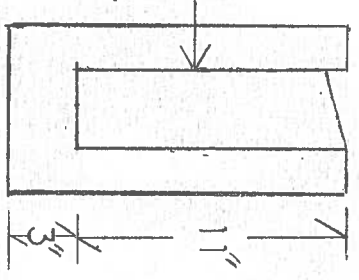
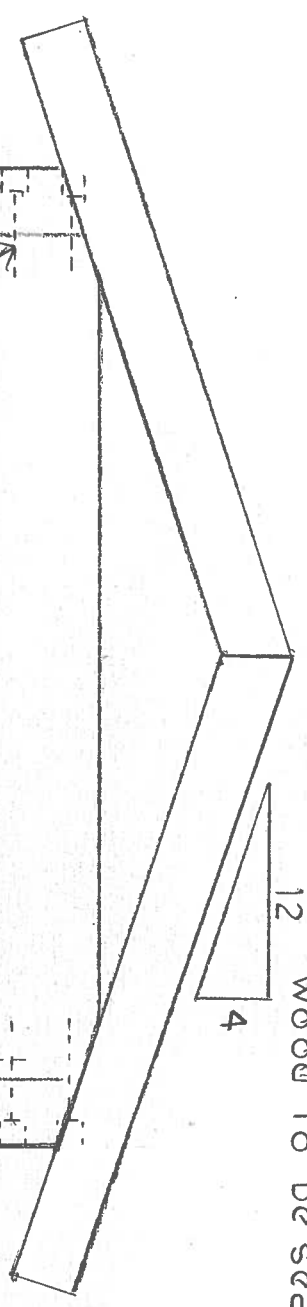
10 x 1/2" lag bolts countersunk  
 7 x 14 cedar  
 2-6" x 4" x 1/4" Steel angle comes with 6 holes for 4 x 1/2" lag bolts  
 scale:  $1''=1'$

All bolts to be galvanized  
 All steel fabrication to be painted black  
 All bolt to wood connection require a galvanized timber washer

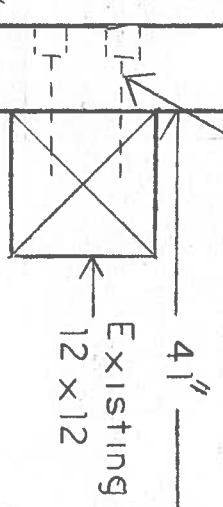
7 x 14 cedar  
 Existing 3 1/2 x 11 steel beam  
 6 x 1/2 thru bolts

7 x 7 cedar  
 scale:  $3''=1'$

10 x 1/2 galvanized lag bolts countersunk
